Riparian Health Summary Final Report

- Moose Lake Tributaries Project Area – Revisit

Part 1: 2014 Results

April 2015

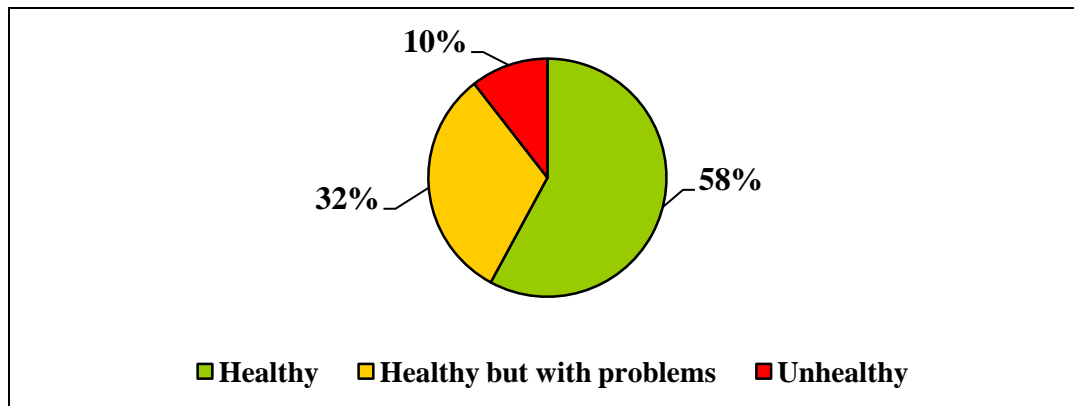
Figure 4. Moose Lake Tributaries Project Area Riparian Health Score Results (2014)
(based on 19 sites)

Of the 19 riparian sites inventoried/assessed in 2014, 11 (58%) rate *healthy*, six (32%) rate *healthy but with problems* and two (10%) are in *unhealthy* condition (Figure 4). The average riparian health score for the project area is 79.7% (*healthy but with problems*). Refer to Appendix B for the project area riparian health score sheet.

Since riparian health inventory sites vary in size, the relative health of the project area based on the area assessed, compared to the number of sites assessed, may differ. For the 19 sites evaluated in the Moose Lake Tributaries project area, the average area-weighted riparian health rating is 81% (*healthy*), slightly higher than by number of sites. By area, approximately 60 ha (69%) of riparian habitat rates *healthy*, 17 ha (22%) rates *healthy but with problems*, and approximately 5 ha (9%) of riparian habitat that rates *unhealthy*.

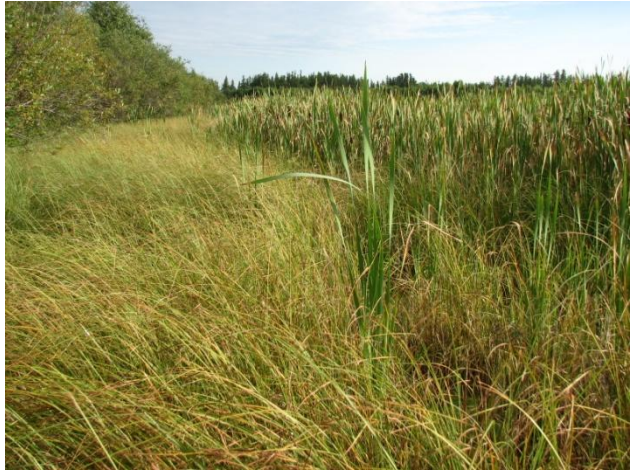
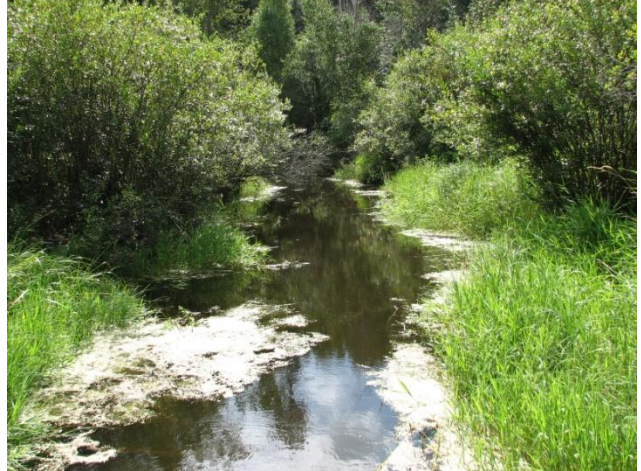
Photo b: Cattail and sedge communities reflect a high water table and healthy riparian areas.

Photo c: Willows provide deep binding root mass and add structure to healthy riparian plant communities.

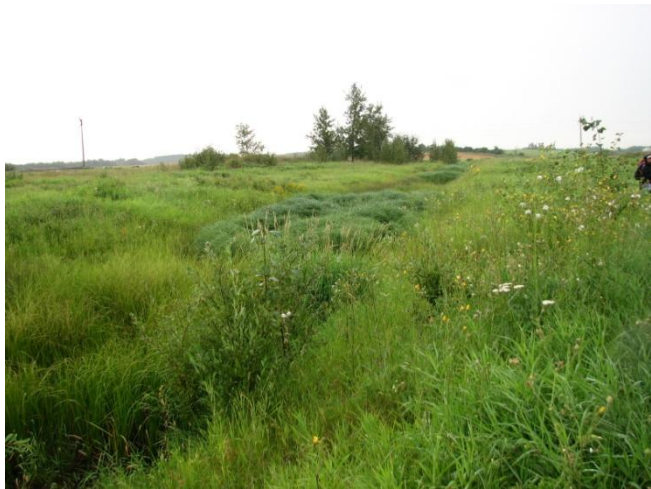
M. Plemel, RHIP02VAL021

Photo d: A straightened channel is well vegetated with riparian grasses and sedges but woody regeneration is minimal. The banks are altered due to the historic channelization.

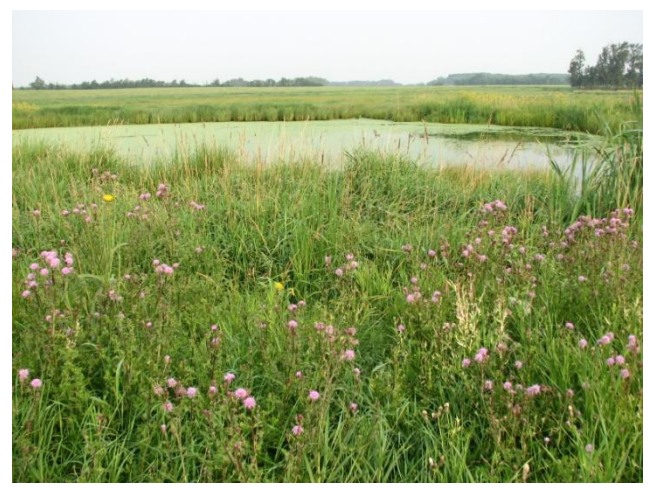
M. Plemel, RHIP03VAL019

Photo e: Invasive species such as Canada thistle and perennial sow thistle are a problem in some riparian areas.

Disturbance-caused undesirable herbaceous species and invasive species are prevalent throughout the Moose Lake Tributaries project area. Disturbance-caused plants are typically non-native grasses and forbs that aggressively displace native plants once the soil surface has been disturbed. Invasive plants are those that are listed on Alberta's *Weed Control Act* as **prohibited noxious** or **noxious** weeds, as well as some additional species identified by Cows and Fish to be invasive within riparian areas. Invasive plants are non-native species that spread rapidly and are difficult to control (Photo e, page 9).

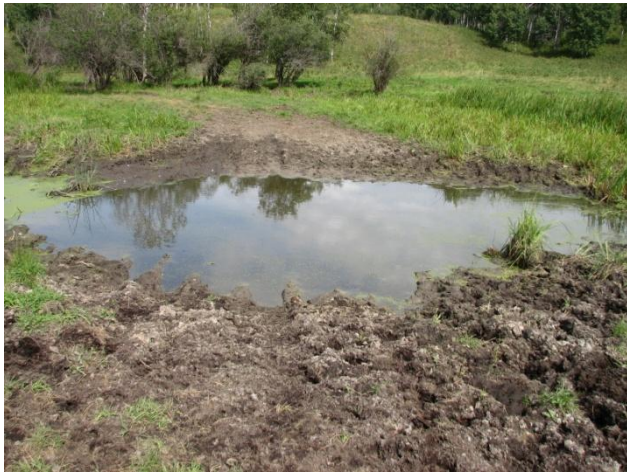
A. Sarrazin, RHIP01KEH027

Photo f: Bare ground creates opportunities for invasive and disturbance plants to become established. Woody plants (in background) display an umbrella shape indicative of grazing periods that are longer than growing season rest periods.

- Achieving the above goals requires ensuring plant communities have enough rest from grazing during the growing season to reduce the amount of bare ground and to allow native plants to out-compete disturbance-caused and invasive plants for nutrients and water. A combination of weed control measures and grazing strategies (where appropriate) that consider distribution, timing and stocking rates will be required.

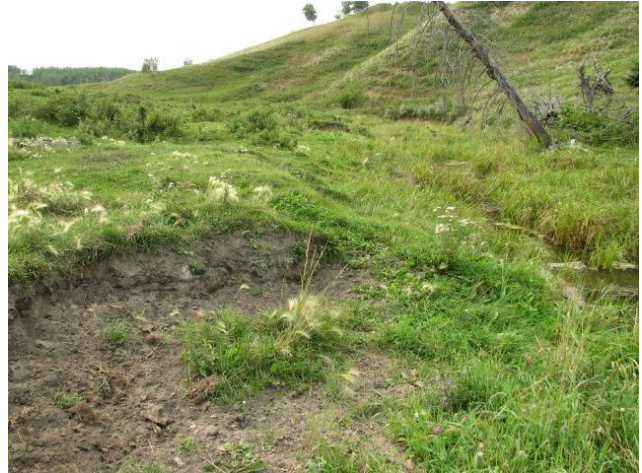
K. Stebanuk, RHIP02YEC025

Photo g: Altered streambanks by hoof shear and little to no willow and other riparian shrubs with deep binding roots result in unstable streambanks.

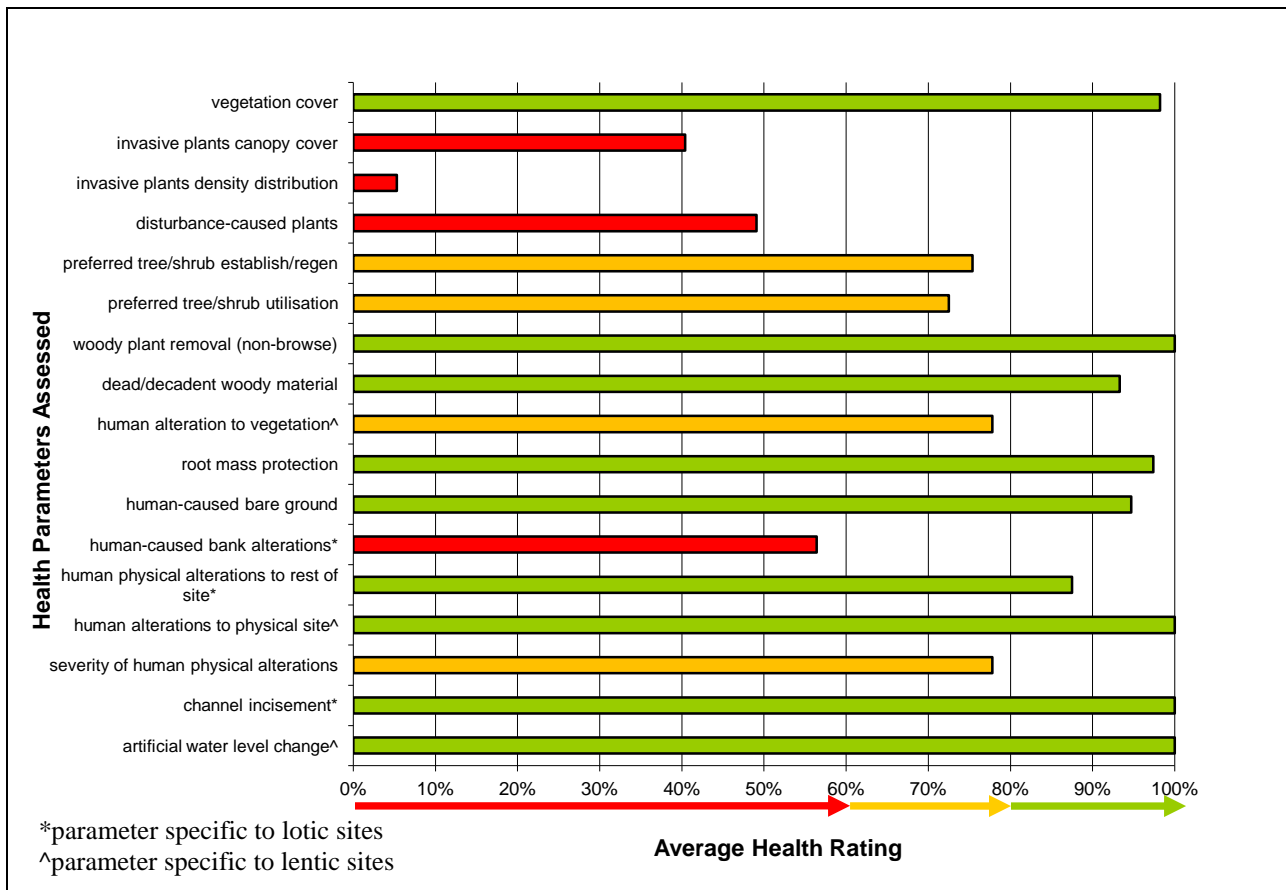
Figure 5. Breakdown of Riparian Health Parameter Ratings for the Moose Lake Tributaries Project Area (based on 19 sites)

Figure 5 provides an overview of the health ratings for each of the riparian health parameters that were assessed. The overall project area rates as *healthy but with problems* on average so there are impacts to riparian vegetation and soil/hydrology health, some of which have resulted from long-term livestock grazing, other agricultural land uses (e.g. haying) and channel modification.

Collectively, the vegetation parameters in the project area rate as *healthy but with problems* (70%). Riparian areas are well vegetated with a diversity of plant species. Refer to Appendix C for a list of all plants found in the Moose Lake Tributaries project area. Detracting from the vegetative health of riparian areas is high proportion of invasive plants and disturbance-caused grasses and forbs.

Soil/hydrology parameters in the project area rate as *healthy* (90%). Human-caused bare ground is limited in most areas and water is able to escape the channel during high flows on all of the waterbodies in the project area. Plants with sufficient root mass to protect streambanks from erosion are abundant in the majority of sites where it could be evaluated. Detracting from the soil and hydrology score of the project area overall is, a high amount of human-caused alterations to the streambank of lotic sites and the severity of human-caused alterations to the riparian area on lentic sites, though the overall area altered is minimal.

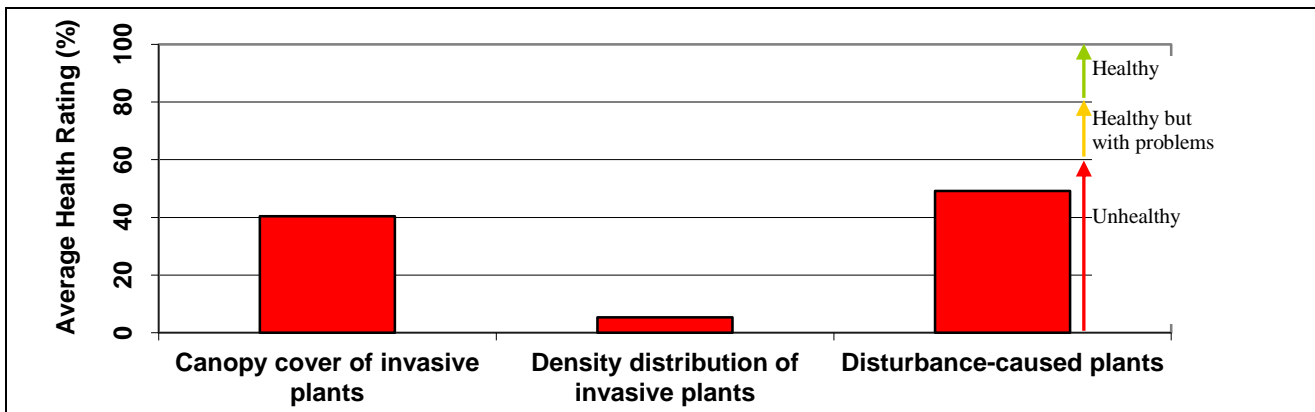
Figure 7. Moose Lake Tributaries Project Area Invasive and Disturbance-Caused Plant Parameters Health Ratings

- Nine of 19 sites have more than 25% of the riparian area covered in disturbance-caused undesirable herbaceous species, while three sites have less than 5% cover of these species. The remaining seven sites have 5% to 25% cover of disturbance-caused plants. Combined, disturbance-caused species cover approximately 18% of the project area and can be indicative of long-term livestock grazing impacts, conversion to tame forage or encroachment from adjacent agricultural land uses and other watershed influences (e.g. seeded road ditches).

- Of the 26 disturbance-caused plant species present, the most prevalent are smooth brome and Kentucky bluegrass¹². Although these plants do provide forage for livestock, compared to native sedges and shrubs, they do not provide adequate amounts of deeply binding rootmass and generally do not perform many riparian functions as well as native species. Banks and shores with only disturbance-caused plant cover are highly susceptible to erosion where a deep binding root mass is lacking.

- **The prevalence of invasive plants is a concern.** Eight noxious weed species were found: smooth perennial sow-thistle (*Sonchus arvensis ssp. uliginosus*), Canada thistle (*Cirsium arvense*), perennial sow-thistle (*Sonchus arvensis*), white cockle (*Silene pratensis syn. Silene latifolia*), common tansy, cleavers (*Galium aparine*), scentless chamomile (*Matricaria perforata syn. Tripleurospermum inodorum*), and common caragana (*Caragana arborescens*). Canada thistle occurs in all 19 sites and has the second highest overall canopy cover in the project area at 2.3%. Perennial sow-thistle and/or smooth perennial sow-thistle are present on all but one site and cover 1.0% to 2.5% of the project area.

- **Prevent an increase in disturbance-caused plants.** Complete elimination of disturbance-caused plants is not realistic. Instead, the best approach is to maintain the health of native plant communities and minimize new ground disturbance from vehicles, livestock or people. Avoid further conversion of native plant communities to hayland or cropland in, or adjacent to the riparian area.

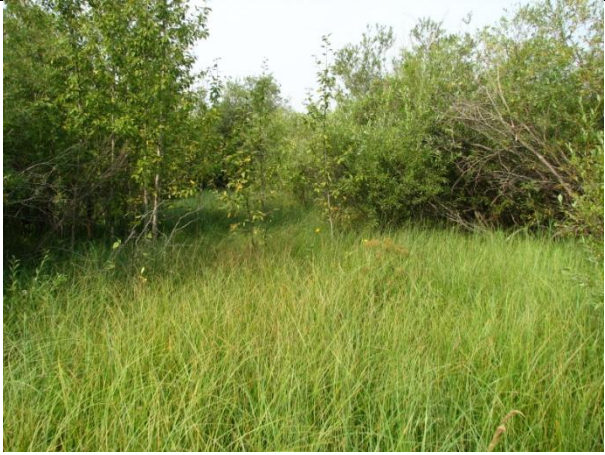
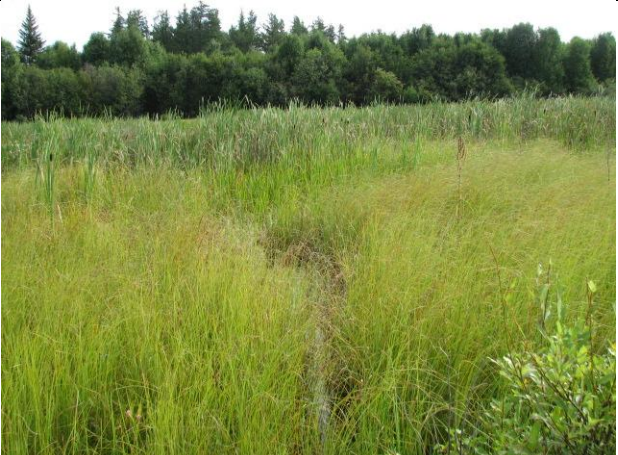
M. Plemel, RHIP01THI022
<p>Photo i: A diversity of age classes of trees and shrubs provides good ecological stability of the riparian area.</p>		<p>Photo j: A variety of native and preferred riparian plant species (woody and herbaceous) are present throughout the project area.</p>

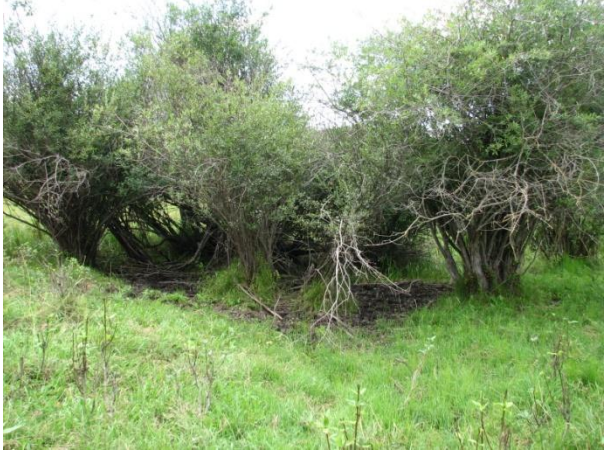
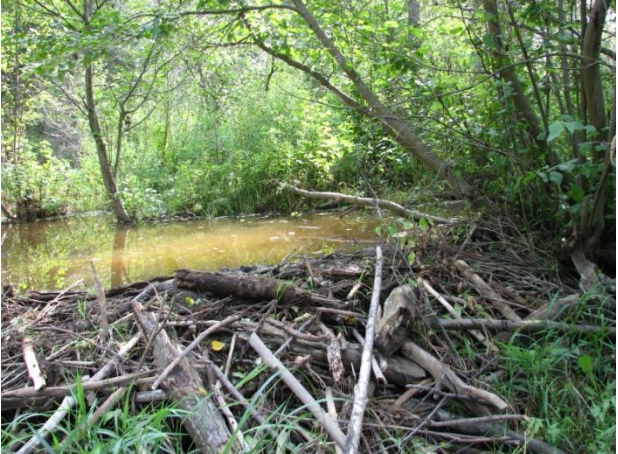
M. Plemel, RHIP04YEC030
<p>Photo k: The umbrella shape of these willows is due to heavy browse utilization.</p>		<p>Photo l: Beaver activity is present throughout the project area but tree and shrub removal is minimal overall.</p>

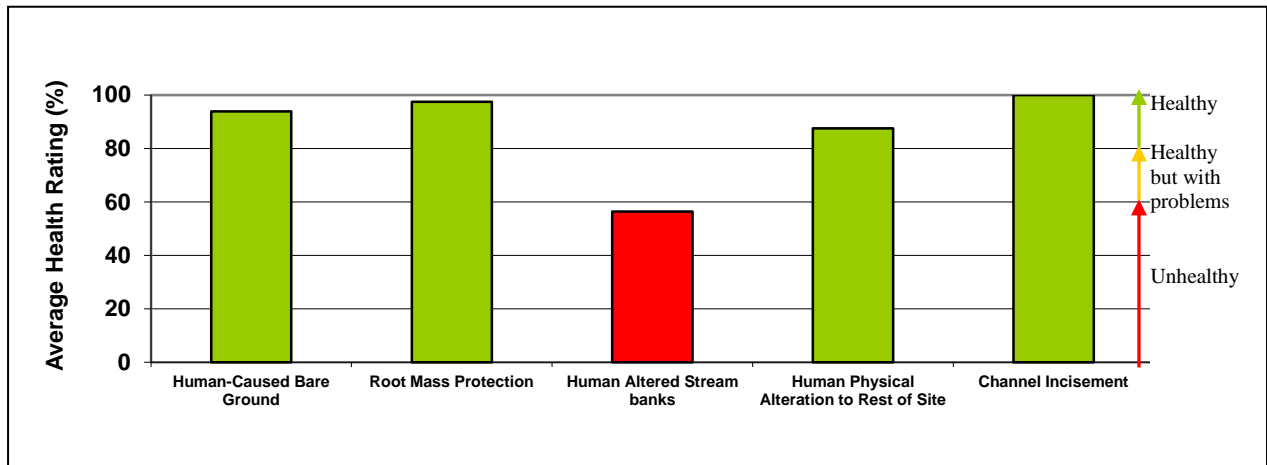
Figure 8. Moose Lake Tributaries Project Area Soil and Hydrology Parameters Health Ratings (16 Lotic Sites)

- 12 sites are completely vegetated with no exposed soil! Of the remaining four sites, two have less than 1%, one has less than 5% and the other has 5% to 15% bare soil.
- The total amount of bare ground on lotic sites in the project area is minimal, approximately 0.8%. Of this, approximately 88% is due to human causes, such as livestock grazing, recreation and industrial development.
- There is also a small proportion of natural bare ground on lotic sites in the project area. Approximately 9% of the bare ground present is from erosion, deposition and wildlife use.

- Bank alterations could not be assessed at three lotic sites, due to the lack of a defined channel and bank.
- The remaining seven sites have some alterations to the banks from human activities. Those alterations impact approximately 28% (2.4 km) of the length of stream and river bank which could be assessed (8.5 km); and of the sites with bank alterations, 62% of that 4.0 km of bank is altered by human causes.
- Of the 13 sites where the bank could be assessed, six have no alterations, one has less than 5% of the stream or river bank altered, one site has 15% to 35% of the bank altered, and the remaining five sites have greater than 35% of the bank structurally altered by human activities. Historic channelization is the primary cause of bank alterations on Valer's Creek and grazing is causing some bank alterations along Yelling Creek.

- Eight sites have no alterations from human causes to the riparian area beyond the banks and eight sites have some alterations. Of those sites with alterations to the floodplain, six have less than 5% of the area altered, and two have greater than 25% of the site (excluding the banks) physically altered by human causes.
- Overall, about 8.5% of the project area (3.7 ha) has human caused alterations to the riparian area beyond the banks. Grazing, along with recreation, roads and industrial development are the causes of the alterations. Soil compaction is the primary kind of alteration to the floodplain though berms (landscaping), hydrologic change, and impervious surfaces are also present.

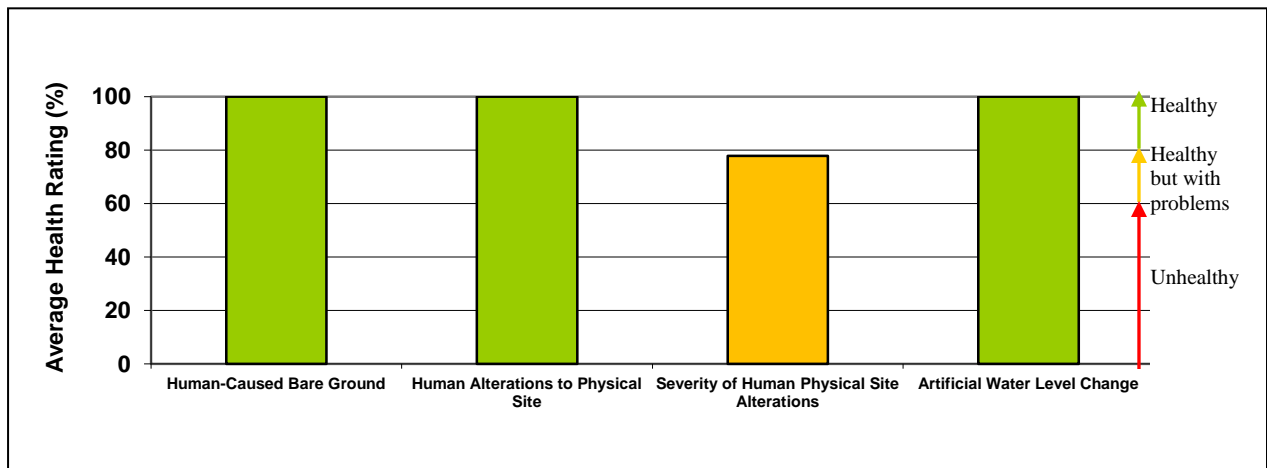
Figure 9. Moose Lake Tributaries Project Area Soil and Hydrology Parameters Health Ratings (3 Lentic Sites)

This section discusses the soil and hydrology parameters relative to the riparian area of the three lentic sites in the Moose Lake Tributaries project area.
