Riparian Health Summary Final Report

- Moose Lake Tributaries Project Area – Revisit

2014 Results & Trend vs. 2005

December 2015

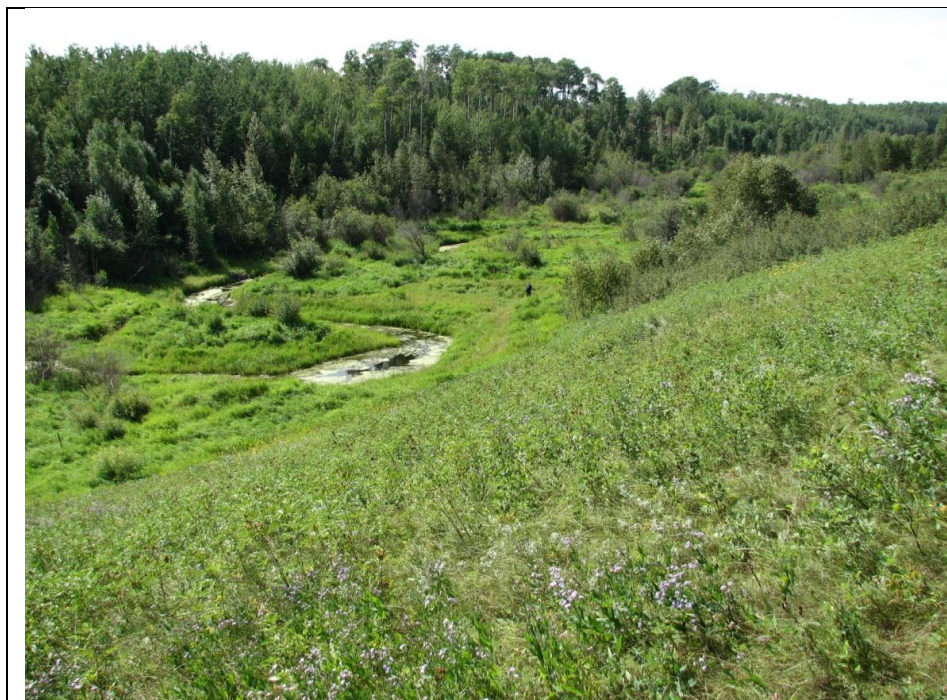
M. Plemel, RHIP07YEC024

Photo a: Riparian area along Yelling Creek in the Moose Lake watershed.

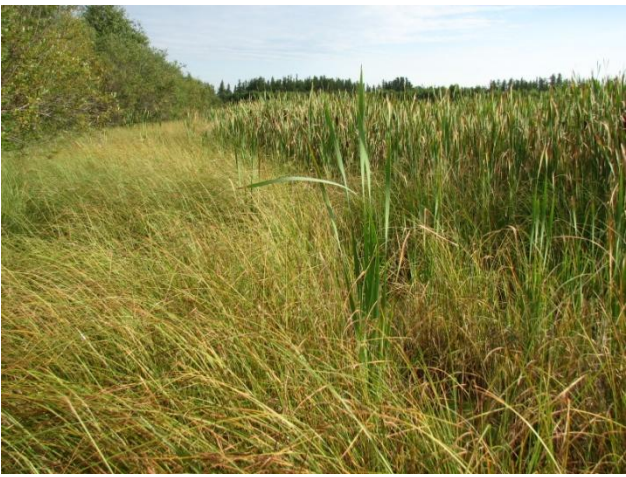
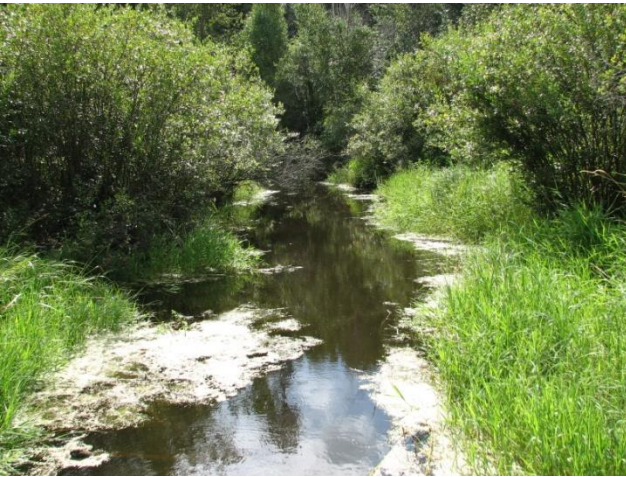
M. Plemel, RHIP01TH015	M. Plemel, RHIP07YEC018
<p>Photo b: Cattail and sedge communities reflect a high water table and healthy riparian areas.</p>	<p>Photo c: Willows provide deep binding root mass and add structure to healthy riparian plant communities.</p>

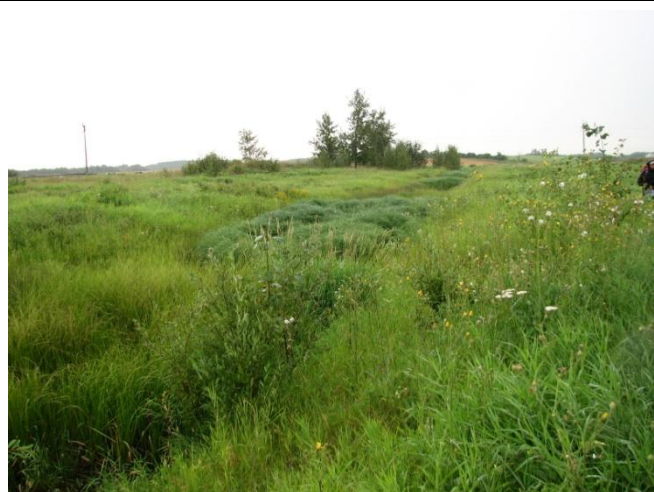
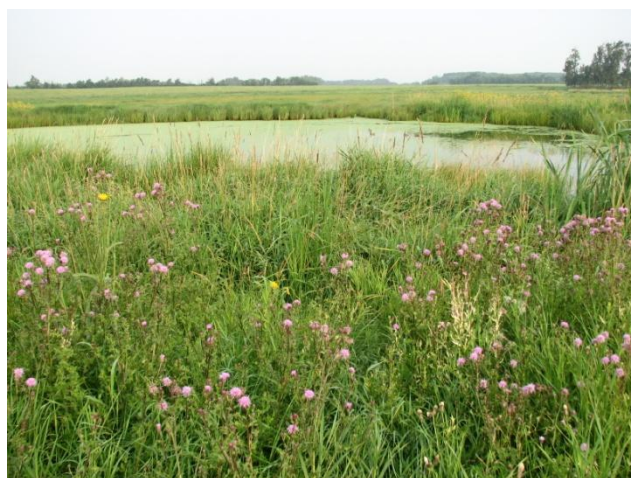
Photo d: A straightened channel is well vegetated with riparian grasses and sedges but woody regeneration is minimal. The banks are altered due to the historic channelization.

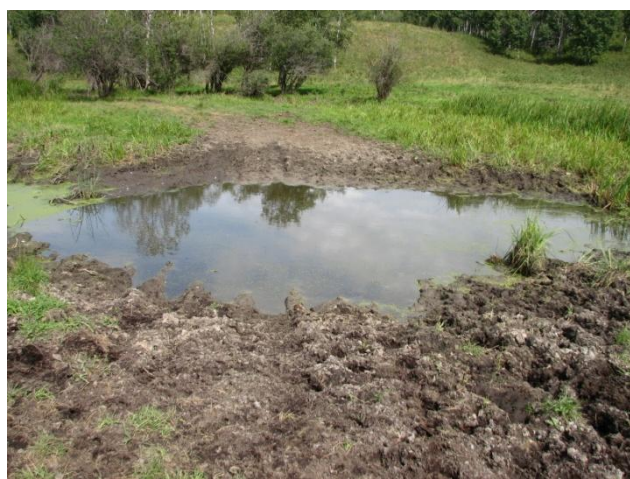
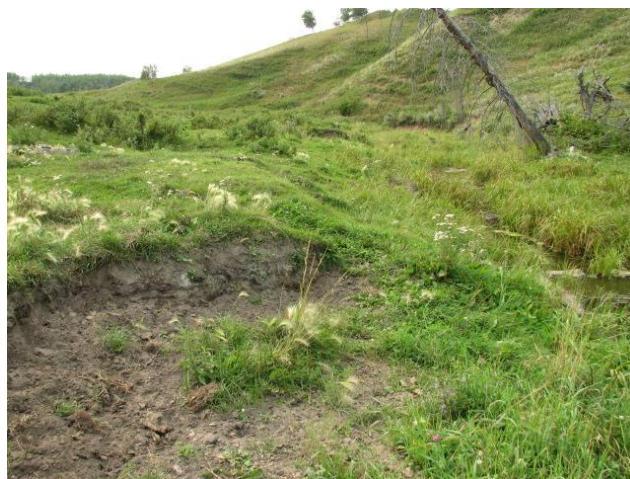
Photo f: Bare ground creates opportunities for invasive and disturbance plants to become established. Woody plants (in background) display an umbrella shape indicative of grazing periods that are longer than growing season rest periods.

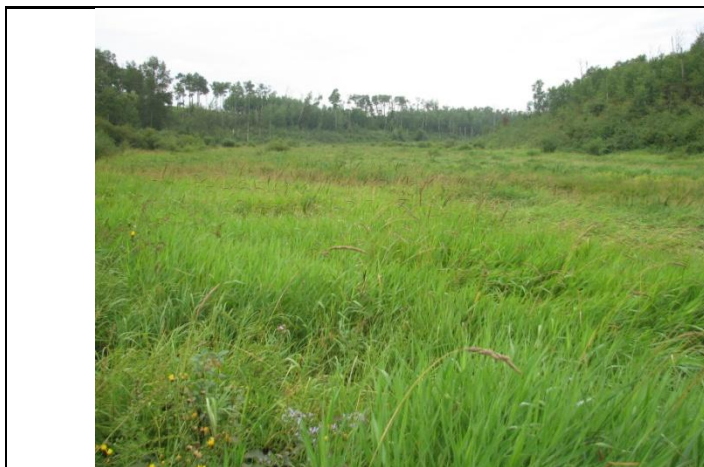
Although considered a native plant, reed canary grass (*Phalaris arundinacea*) can be an introduced plant community, with a highly invasive nature where it was originally seeded as part of a hay or tame pasture seed mix in the Parkland Natural Subregion⁹. The reed canary grass habitat type comprises almost 11% of the project area (Photo h) and is likely present as a result of encroachment from surrounding landscapes in most instances as opposed to being seeded directly into the riparian area. The conversion of native riparian habitat to hayfields, and tame pastures negatively impacts riparian health because often trees and shrubs are removed which results in loss of native biodiversity and reduced habitat structure and food sources for fish and wildlife, as well as compromised bank stability, increased erosion,.

Photo h: Reed canary grass covers 11% of the project area and as seen here can form dense plant communities.

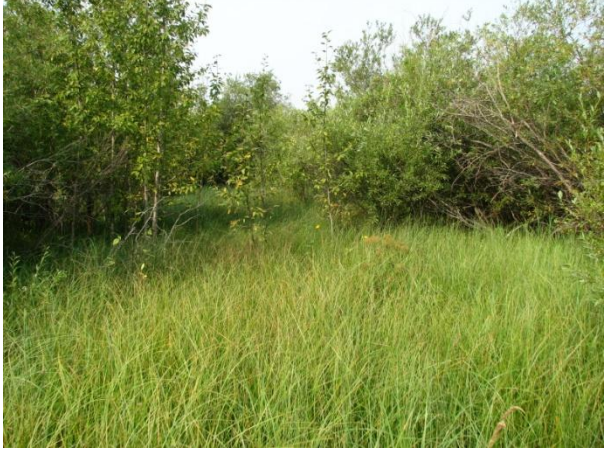
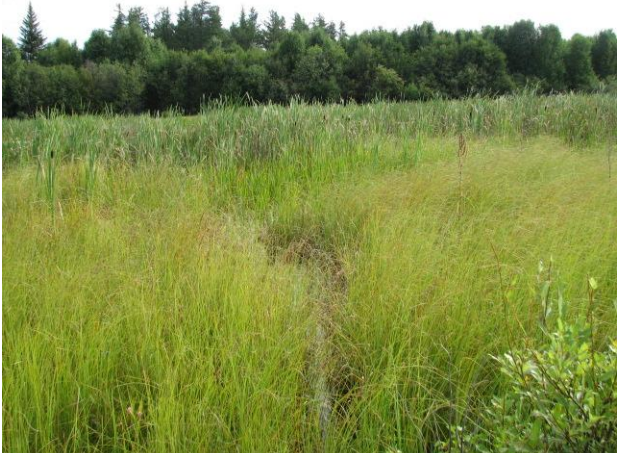
M. Plemel, RHIP01THI022
<p>Photo i: A diversity of age classes of trees and shrubs provides good ecological stability of the riparian area.</p>		<p>Photo j: A variety of native and preferred riparian plant species (woody and herbaceous) are present throughout the project area.</p>

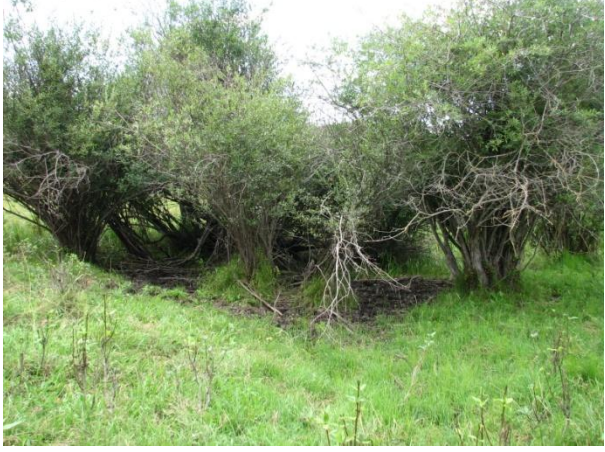
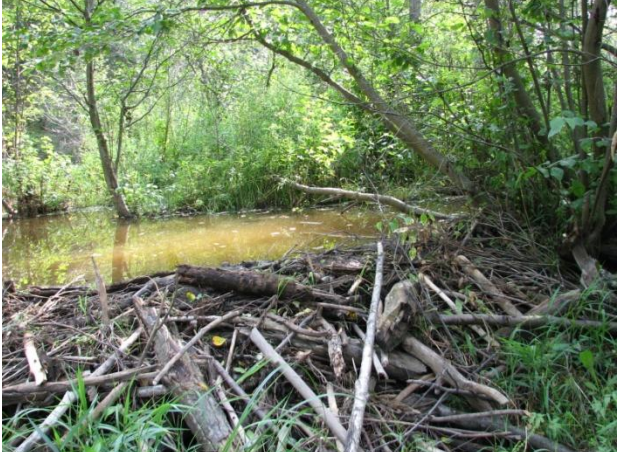
M. Plemel, RHIP04YEC030
<p>Photo k: The umbrella shape of these willows is due to heavy browse utilization.</p>		<p>Photo l: Beaver activity is present throughout the project area but tree and shrub removal is minimal overall.</p>

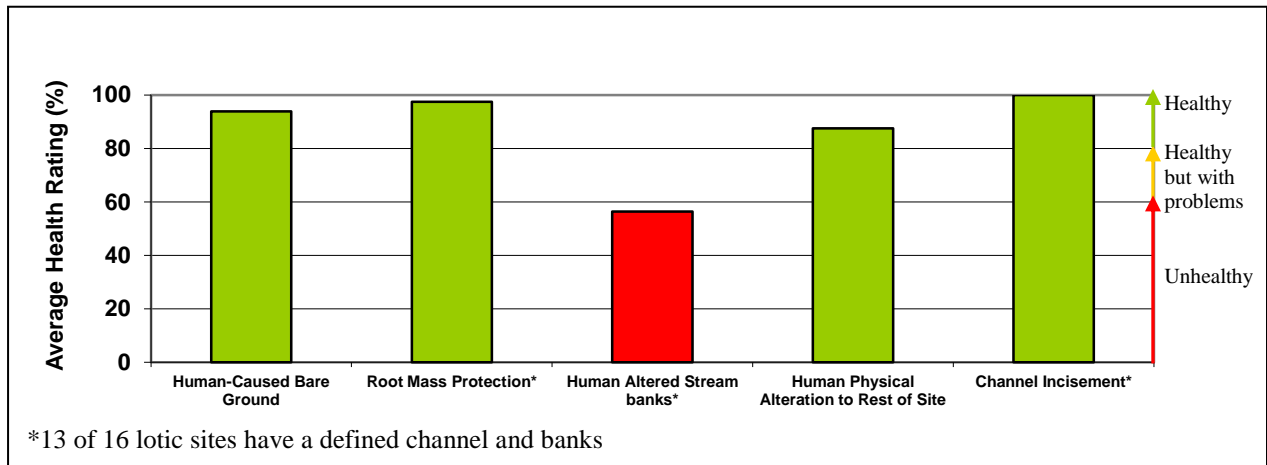
Figure 8. Moose Lake Tributaries Project Area Soil and Hydrology Parameters Health Ratings (2014) (based on 16 lotic sites)

This section discusses the soil and hydrology parameters relative to the riparian area including stream/river banks and floodplains of lotic sites. There are 16 lotic sites in the Moose Lake Tributaries project area (15 inventories and one assessment (survey)).

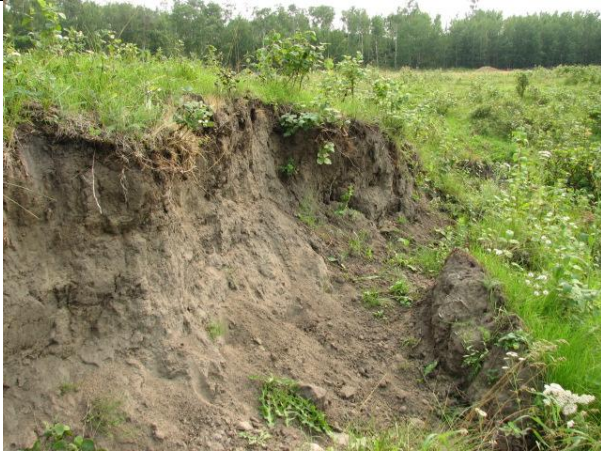
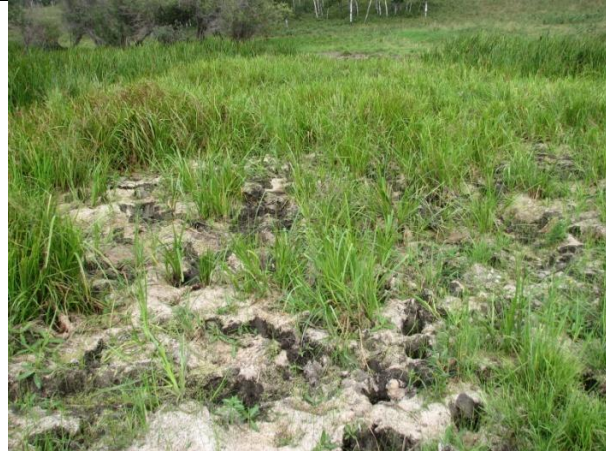
Photo m: A lack of deep rooted plant material has caused this portion of bank to be unstable and slumping. This is not common on most sites in the project area but is a concern on certain sites.

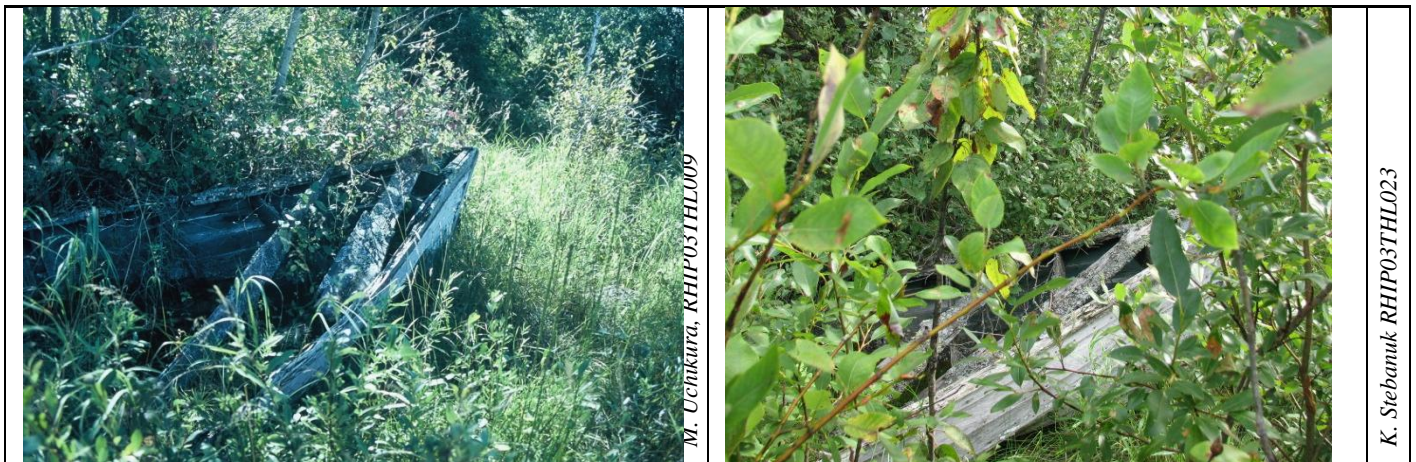
Photo p: September 1, 2005. Old wooden boat frame at the base of the slope is surrounded primarily by grasses.

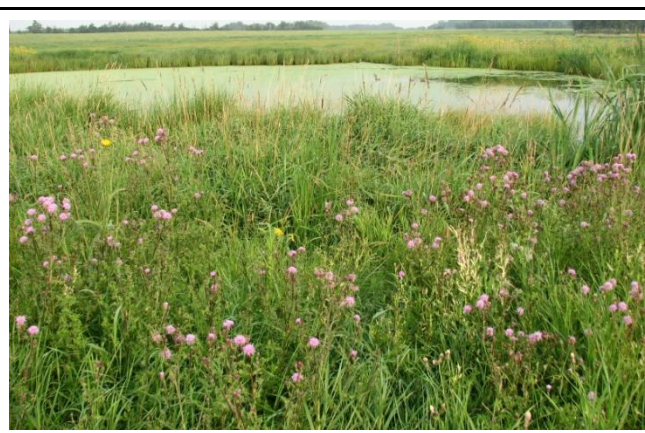
M. Plemel, RHIP03VAL019

Photo r: Disturbance caused plants like clovers offer ground cover but don't have deep binding roots.

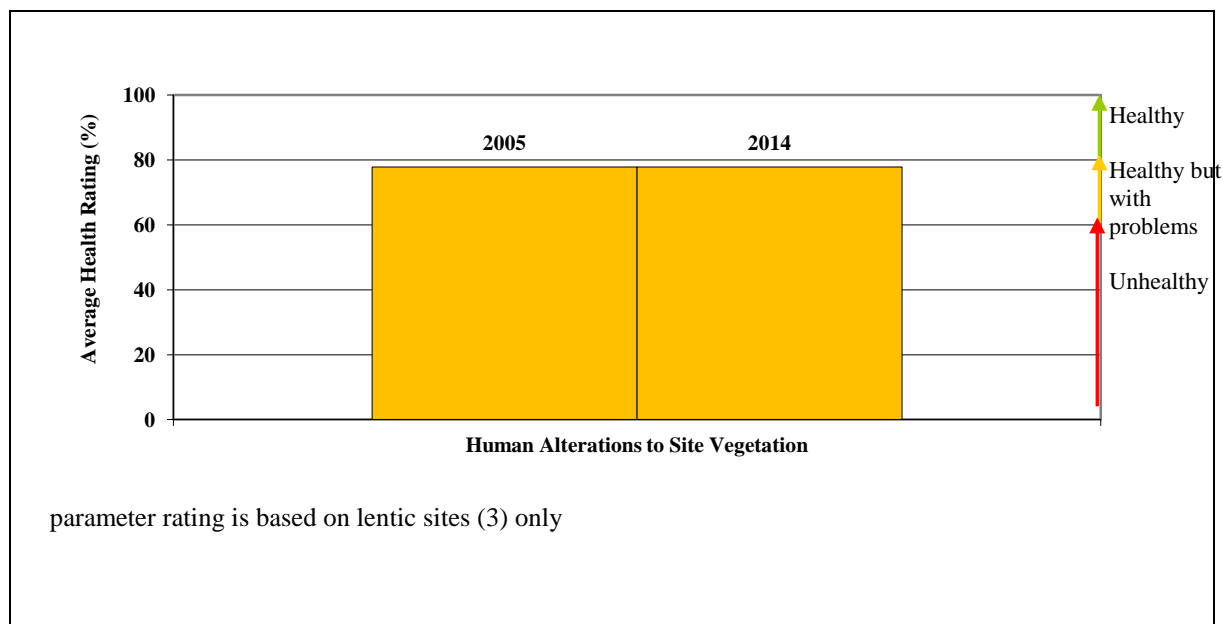
Figure 15. Comparison of Human Alterations to Site Vegetation Parameter Health Ratings: 2005 vs. 2014 for Three Lentic Revisit Sites within the Moose Lake Tributaries Project Area

- **Overall Trend: Human-caused alterations to riparian vegetation remains in the same health category overall (Figure 15).**

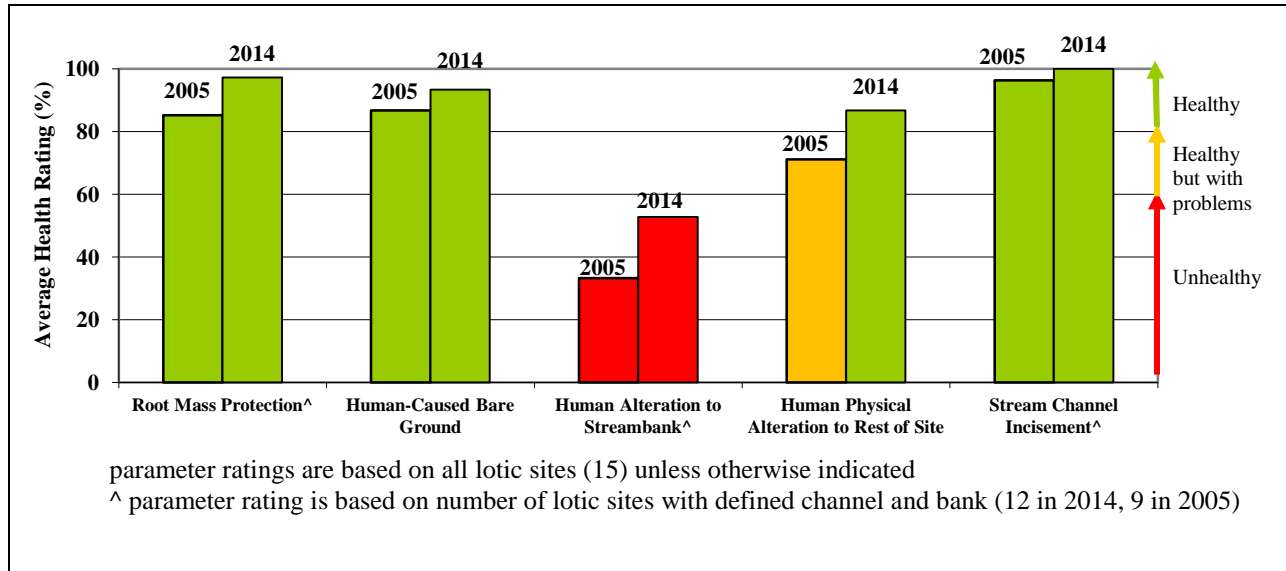
Figure 17. Comparison of Soil and Hydrology Parameters Health Ratings: 2005 vs. 2014 for 15 Lotic Revisit Sites within the Moose Lake Tributaries Project Area

- **Overall Trend: All physical parameters for the creek and river sites show improvement within their health categories and one has improved a health category (Figure 17).**

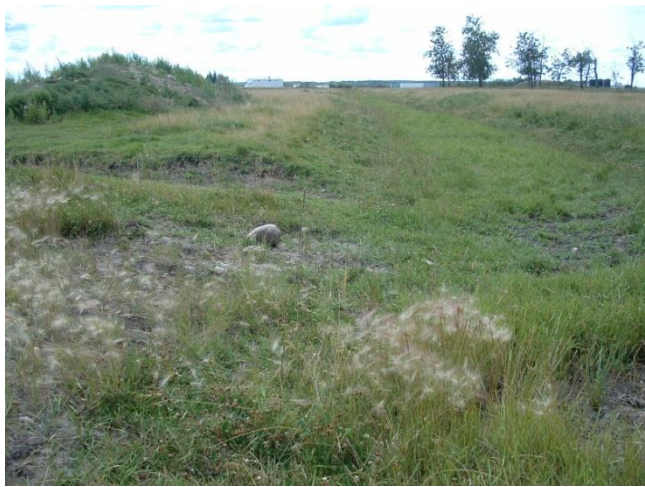
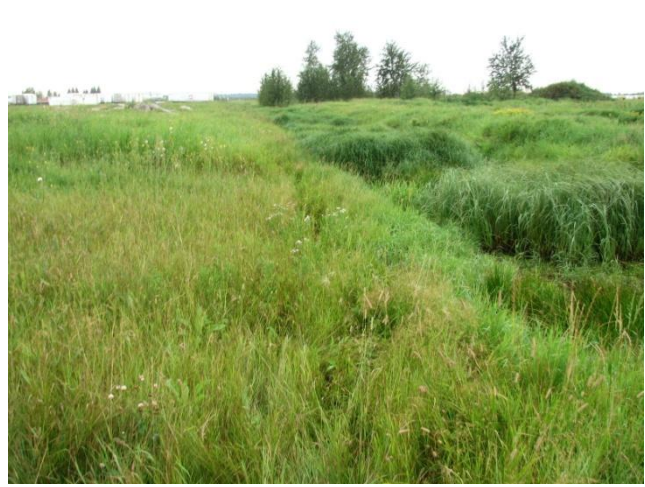
Photo t-b: August 13, 2014. Channel is still straight so altered banks remain. However, riparian vegetation is more abundant with sedges in the channel. This site has not had grazing for a few years now.

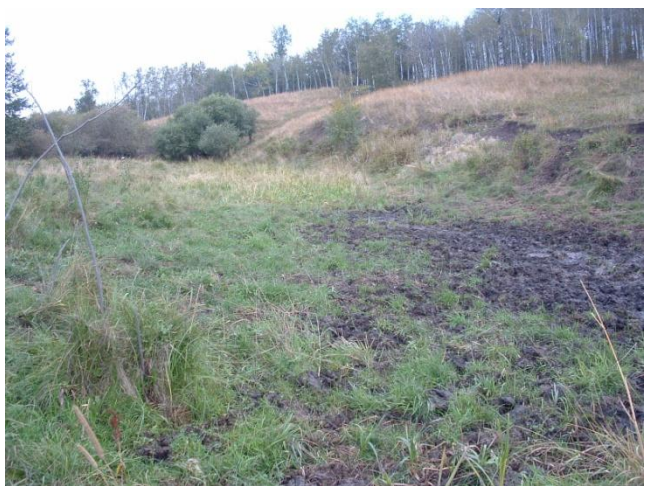
M. Uchikura, RHIP01KEH002

Photo u-a: September 2, 2005. Some livestock activity in the project area created pugs and hummocks and bare ground.

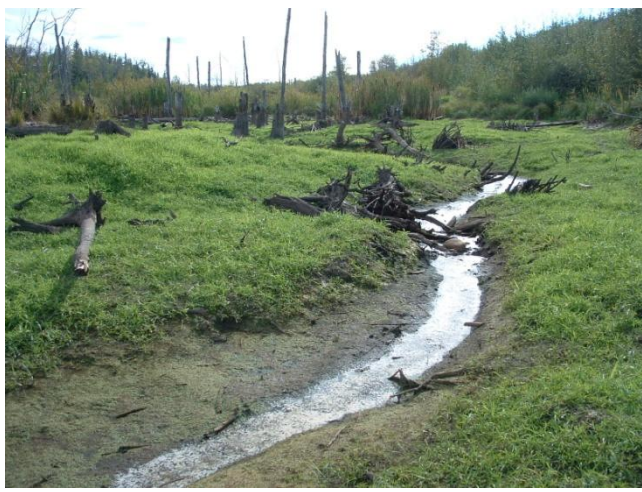
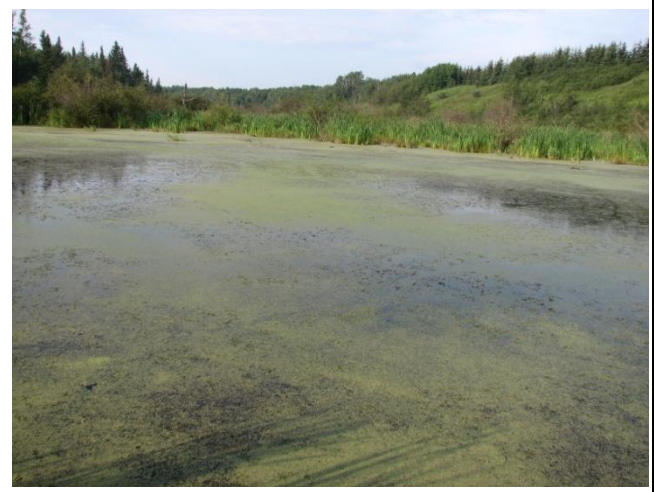
Photo v-b: August 18, 2014. The valley bottom here is now entirely covered in water due to continued beaver activity in the valley. Vegetation includes a cattail community in the distance.

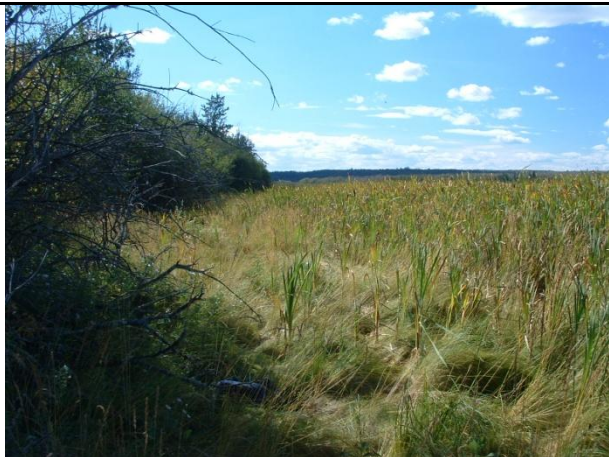
M. Uchikura, RHIP02THI003

Photo w-a: September 1, 2005. Due to the extensive cattail communities this site does not have a defined streambank or channel though there may be one more towards the middle of the valley. Parameters about streambank and channel cannot be assessed in this situation.
